LESSONS LEARNED FROM THE 15 JANUARY 1993 KUSHIRO-OKI, JAPAN EARTHQUAKE

Takeyasu SUZUKI

Research Engineer, Technical Research & Development Institute, Kumagai Gumi Co., Ltd.,
1043 Shimoyama, Onigakubo, Tsukuba-shi, IBARAKI 300-11, JAPAN

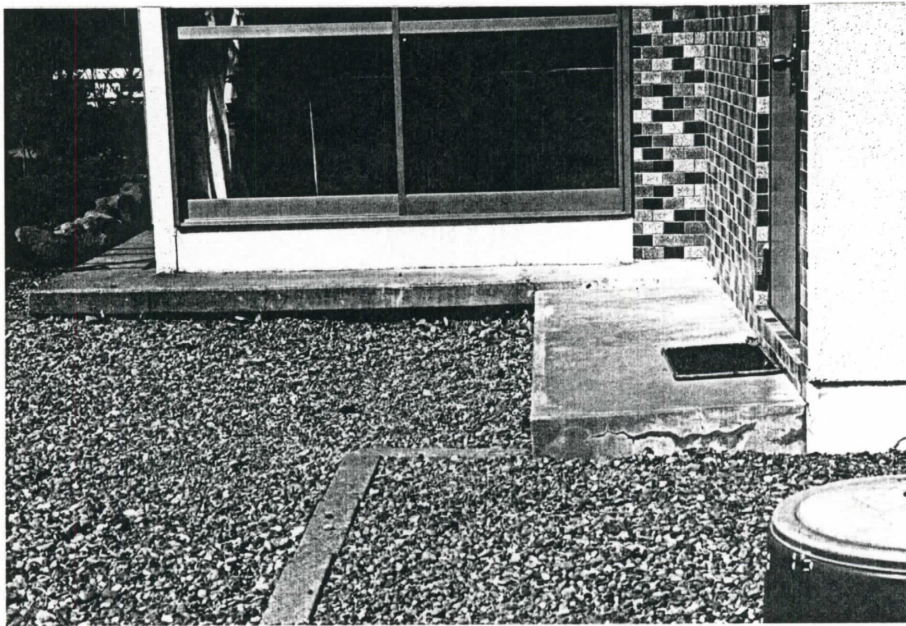
Earthquake damages at Mihara is characterized by the subsidence ranging from 30 to 40 cm as illustrated in Photo. 1. Hokkaido Island is located in the northern part of Japan and the temperature there is always under 0 degree in Centigrade in winter. Therefore, the surface soil is frozen even in the day time until May. The thickness of frozen soil is 150 cm in mid-winter. The subsidence was estimated to occur by the dynamic compaction of fill material and peat including dissipation of pore water pressure built up by cyclic loading. When the frozen soil on the surface melts in spring, secondary subsidence will occur³⁾. Moreover, the excess pore water pressure built up in peat layer will be gradually dissipated year to year, which leads to gradual

increase in subsidence at Mihara. As shown in Photo.1, the gaps between the concrete plates of the entrance and ground can be seen in many houses. The foundation of houses in this region is deep and its thickness is about 1.0 m. However, such secondary subsidence may lead to tilting of houses.

Photo.1 Typical Earthquake damage at Mihara

- (1) In case of horizontally layered soft soil deposit, the development should be conducted in deep consideration of both static and dynamic subsidence. The appropriate method of construction should be adopted. Furthermore, methods of soil improvement with low cost is necessary to be developed.
- (2) In case of irregularly bounded soil deposit, the amplification of earthquake motions at local area should be considered in terms of earthquake-resistant design.
- (3) On relatively hard diluvial hill, the earthquake motions with high acceleration and high frequency may predominate. In this area, there is a possibility that high inertial force generates.

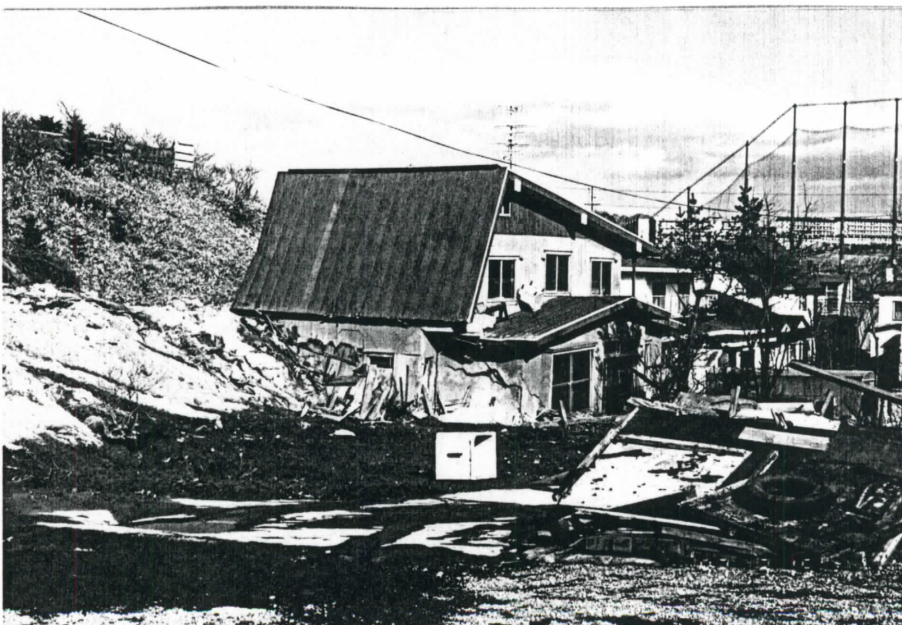
Earthquake damages at Midorigaoka is characterized by the ground failure. Since Midorigaoka is located on diluvial hill, various slopes distribute around and on the hill. Photo. 2 illustrates one of the severest damage due to slope failure at Midorigaoka. As described later, high acceleration of earthquake motion with high frequency will have sufficient inertial force to cause slope failure. The typical damage due to ground failure other than slope failures is the large local amplification of ground acceleration in the area of fill over drowned valley⁵⁾, where the slope on the ground surface is not steep. Surface soil deposit filled using the material moved from cut slopes is irregularly bounded by fresh diluvial loam. The earthquake wave is highly amplified especially in the section of inclined bed rock and the surface deposit would move along the bed rock slope permanently. Due to such permanent displacement of surface deposit, large number of gas pipe damage took place in the area.

Photo.2 Typical Earthquake damage at Midorigaoka

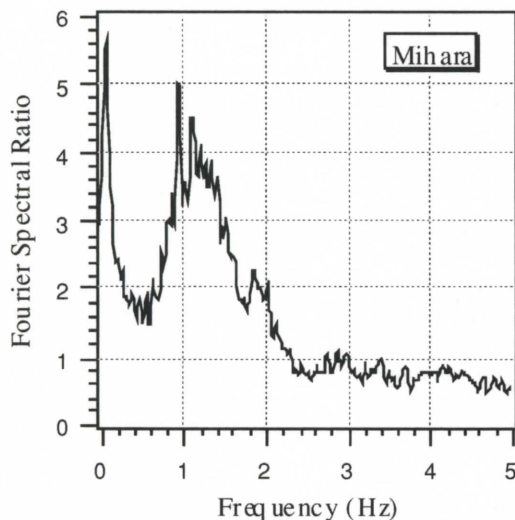
The Fourier spectral ratio at Mihara-5 in the NS direction is illustrated in Fig.3. The predominant frequency around 1.0 Hz can be clearly demonstrated in the figure. The aforementioned ratio at the peak is 5.0. When Fig.3 means the frequency response function at Mihara, one can recognize that the fundamental mode of shear vibration is greatly predominant and that the vibration in high frequency does not amplified by the surface layer. Earthquake motions recorded at Kushiro District Meteorological Observatory, located on diluvial hill area near the sea, shows high frequency of vibration and short duration time. The acceleration at Mihara due to this earthquake is considered to be comparatively low, because of high damping in soft soil and lack of low frequency input motions. The trace of liquefaction was discovered in the area. However, the damage was characterized by the subsidence due to the dissipation of excess pore water pressure in fill, peat layer and sand underlying peat layer.

Fig.3 Fourier Spectral Ratio at Mihara

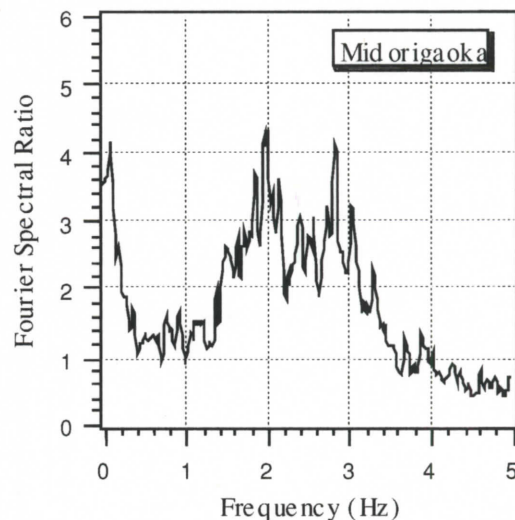
The Fourier spectral ratio at Midorigaoka in the NS direction is illustrated in Fig.4. The figure shows the predominant vibration ranging widely from 1.5 to 3.5 Hz. This means that high frequency of vibration is predominant and 2 or 3 modes of vibration occur originated from the irregularly bounded surface ground. The peak value of the ratio is about 4.0, which is low compared with that at Mihara. As mentioned above, over 900 gals of acceleration was recorded on the diluvial hill. The amplification ratio is not so high on this area. However, acceleration is estimated to be considerably high with high frequency. Fig.4 describes why earthquake damage like Photo.2 occurred at Midorigaoka.

Fig.4 Fourier Spectral Ratio at Midorigaoka
