DAMAGES OF URBAN TUNNELS DUE TO THE SOUTHERN HYOGO EARTHQUAKE OF JANUARY 17, 1995 AND THE EVALUATION OF SEISMIC ISOLATION EFFECT

TAKEYASU SUZUKI

Technical Research and Development Institute, Kumagai Gumi Co., Ltd,
1043 Onigakubo, Tsukuba-shi, 300-22 IBARAKI, JAPAN

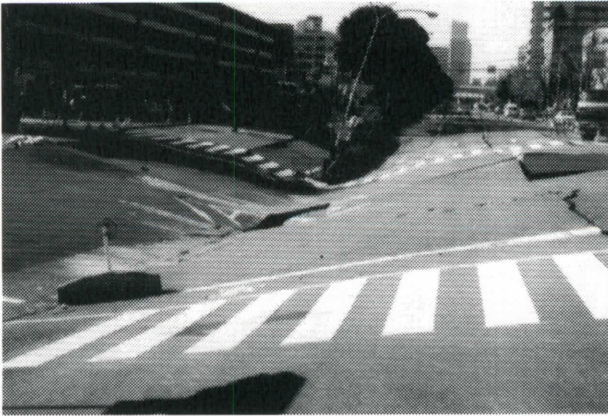
Photo.1 Subsidence of the pavement occurred over the subway station

The severest damage occurred at the Daikai station, the location of which is pointed out in Fig.1. At this station, over 14 center columns were completely collapsed and the ceiling slab bent down to the floor slab. On the ground surface right over the collapsed portion, a large subsidence with almost 80 m in length, 20 m in width, and 1 m in depth at maximum, took place as shown in Photo.1.
